CENTRAL INTELLIGENCE AGENCY

INFORMATION REPORT

SUBJECT Bratislava Port Facilities on the Danube

PORT FACILITIES

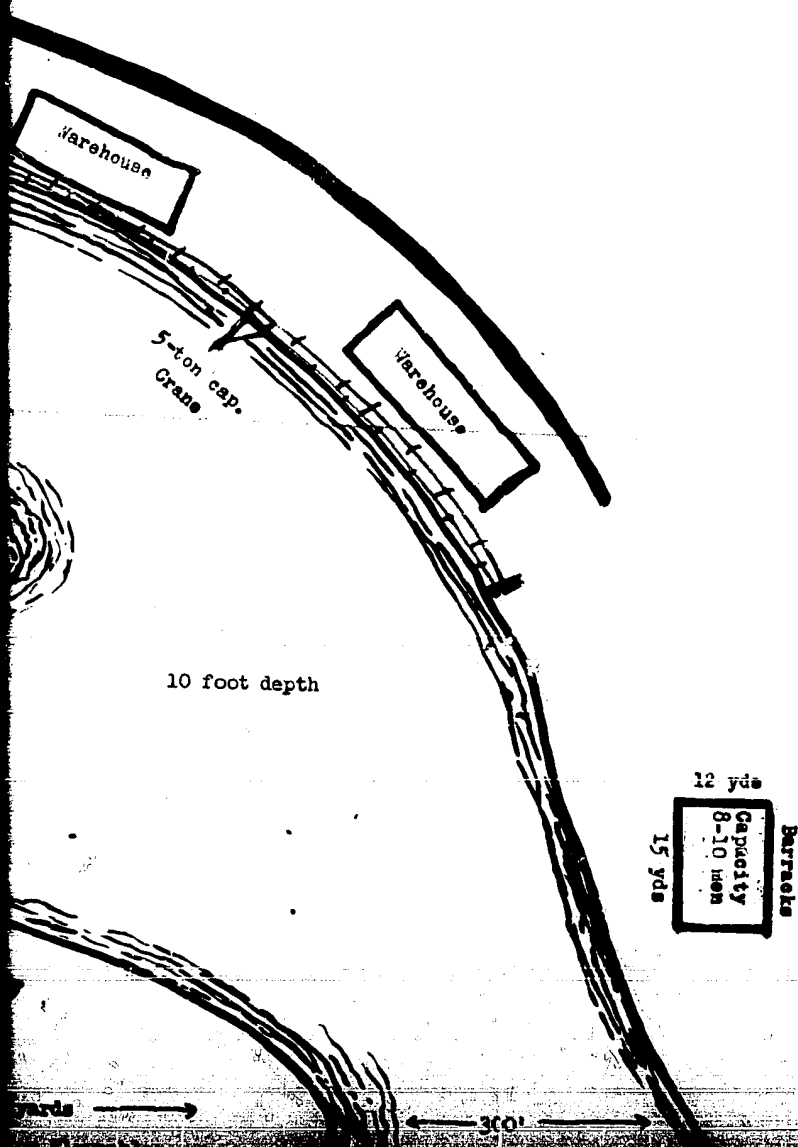
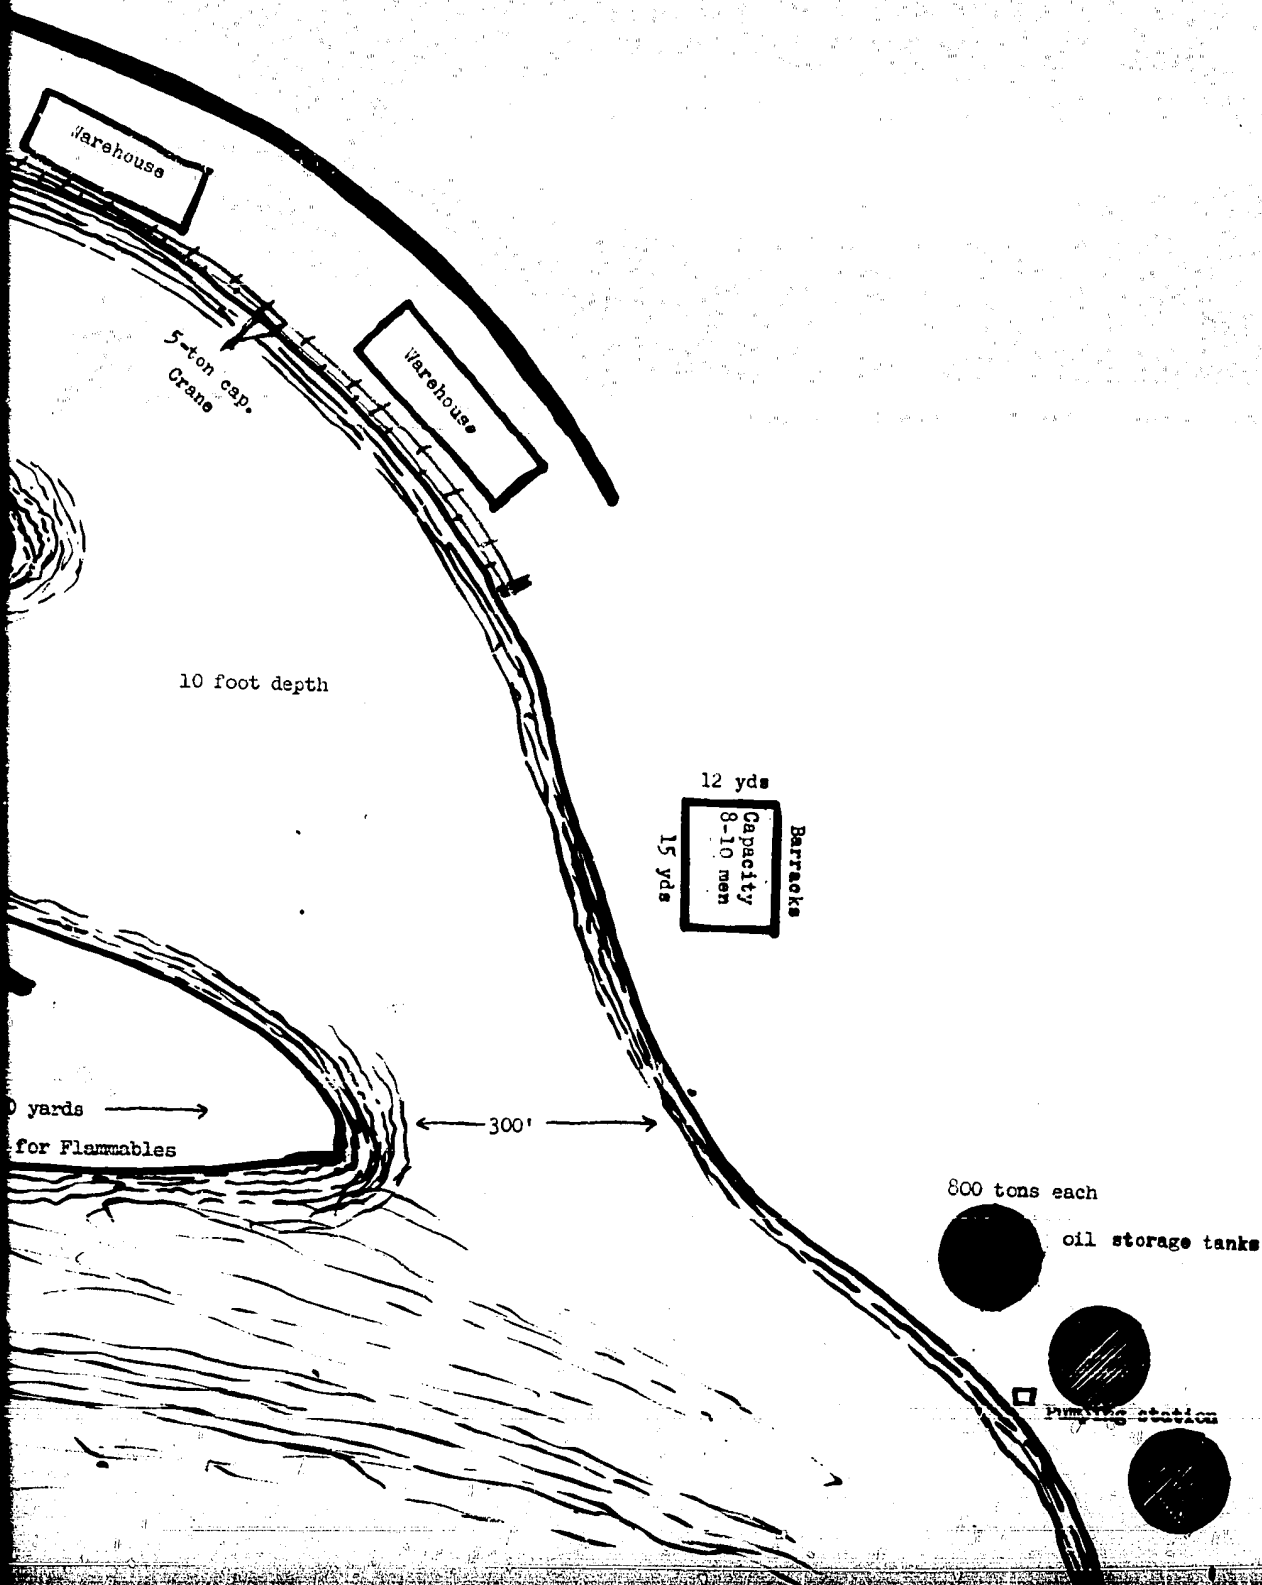
BRATISLAVA, CZECHOSLOVAKIA

1948

Scale - (Approx.) 1 inch = 0.80 yds

3. There were 18 warehouses in the dock area, all of one-story construction. These were all dry storage buildings. There were no facilities for cold storage. Various types of goods were stored in these warehouses that were awaiting shipment or transshipment. Oil storage tanks were located to the southeast, well out of the area, for protection. Each tank had a capacity of about eight hundred tons each. The river ships would be drawn up to the oil storage area, anchored, and then the oil would be pumped into the tanks by means of a pumping station.

4. Two boat basins had been constructed just off the river proper. The one to the south was known as basin No 1, and the one to the north, basin No 2. Basin No 1 had a skid system of three skids that were used to raise ships out of the basin for repairs. Machine shops for small and large repairs were located to the west and south of basin No 1.

5. There was one large crane of about 10-ton capacity located on the Danube proper. All other cranes in the area were five-ton capacity. There was also a grain elevator located on the Danube, south of basin No 1. This elevator was used for a short time in 1945 and 1946 to handle UNRRA wheat.
